DEPARTMENT OF TRANSPORTATION

Quality Assurance and Source Inspection

Contract #: 04-0120F4Cty: SF/ALA Rte: 80 PM: 13.2/13.9File #: 1.28**WELDING INSPECTION REPORT****Resident Engineer:** Casey, William**Address:** 333 Burma Road**City:** Oakland, CA 94607**Report No:** WIR-026798**Date Inspected:** 29-Nov-2011**Project Name:** SAS Superstructure**OSM Arrival Time:** 1000**Prime Contractor:** American Bridge/Fluor Enterprises, a JV**OSM Departure Time:** 1730**Contractor:** American Bridge/Fluor Enterprises, a JV**Location:** Jobsite**CWI Name:** Jesus Cayabyab**CWI Present:** Yes No**Inspected CWI report:** Yes No N/A**Rod Oven in Use:** Yes No N/A**Electrode to specification:** Yes No N/A**Weld Procedures Followed:** Yes No N/A**Qualified Welders:** Yes No N/A**Verified Joint Fit-up:** Yes No N/A**Approved Drawings:** Yes No N/A**Approved WPS:** Yes No N/A**Delayed / Cancelled:** Yes No N/A**Bridge No:** 34-0006**Component:** West Jacking Saddle**Summary of Items Observed:**

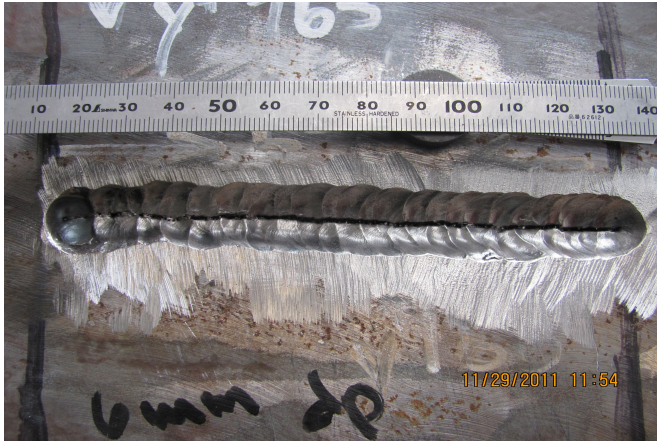
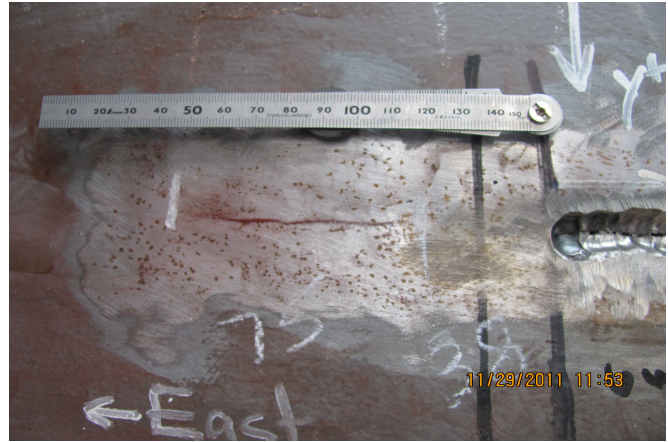
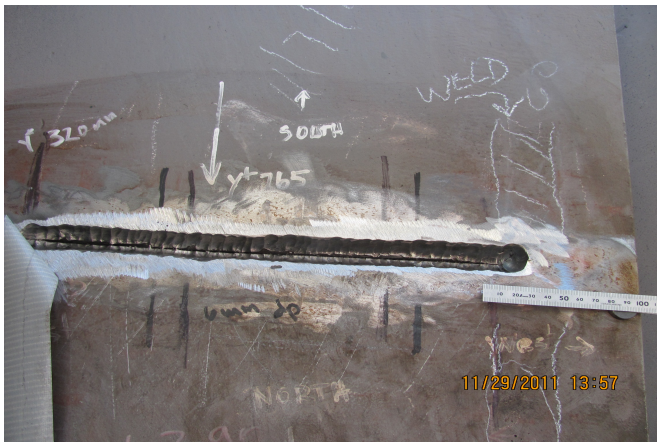
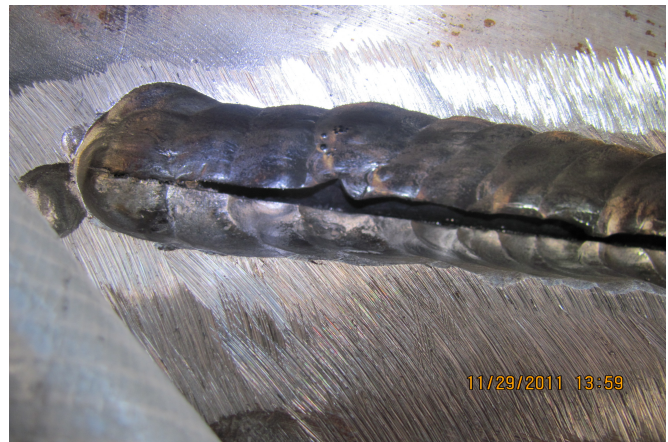
W-2 Jacking Saddle – Jacking Frame: This QA Inspector observed a rejectable linear indication on the jacking frame was marked for repair. The indication was marked as having a length of 120 mm. Caltrans Engineer, Doug Wright showed all persons present that and additional indication was present but not marked on the weld. The PJP weld was designed to have an effective throat of 14 mm. This QA Inspector observed as ABF welding personnel Rick Clayborn (#2773) perform air carbon arc gouging to excavate the marked defect. This QA Inspector observed ABF welding personnel Rick Claybon (#2773) made two passes using the carbon arc process and then stopped. The welder stated the weld thickness was very shallow. This QA Inspector observed the depth of the excavation was 6mm at this point and could see what appeared to be the root opening.

After additional excavation was done, it was observed the weld joint appeared to be beveled 17mm per approved ZPMC drawing WJF-0 2/3 however the weld metal was not sufficient to meet the required 14mm weld size. It varied from 6mm to 11mm. QA also observed the indication propagated towards the vertical shop weld that attaches the cover plate to the frame. METS SMR Kit Guest and Caltrans engineer Doug Wright also observed the excavation process.

QA notified METS SMR Kit Guest of the observations. QA also discussed the issue with Caltrans engineers Brian Boal and Doug Wright. They both suggested METS perform MT on the other similar welds and inquired if UT could be done to evaluate the weld bevel and weld size. They were informed both could be done however the UT would be a "best estimate" on weld size.
